Dynamic Dunescapes Dune Management Case Study

Invasive Species (Sea buckthorn) Removal, UXO (unexploded ordnance) at Pembrey, South Wales

Sand dune system	Pembrey, South Wales
Case Study Subject	UXOs / Invasive species removal followed by unplanned burning of removed materials on site
The Management Intervention

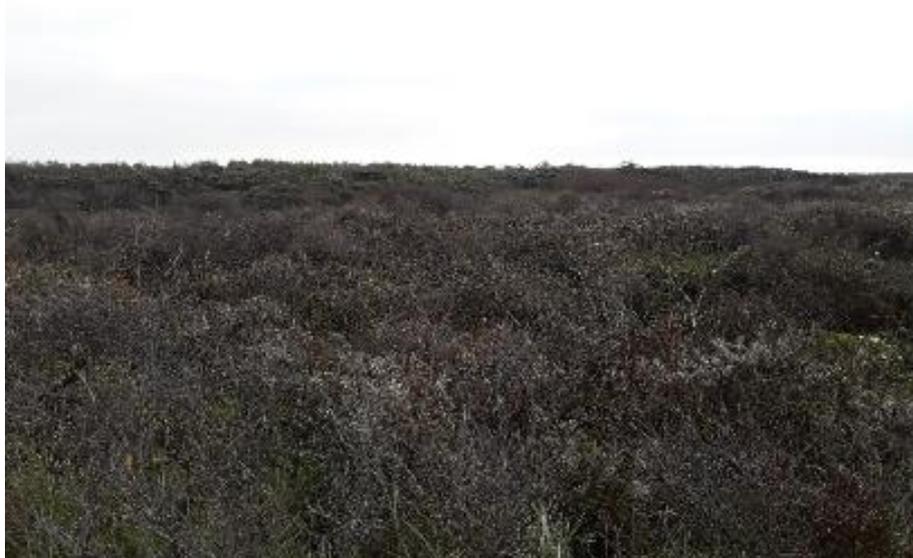
Dense sea buckthorn before works commenced

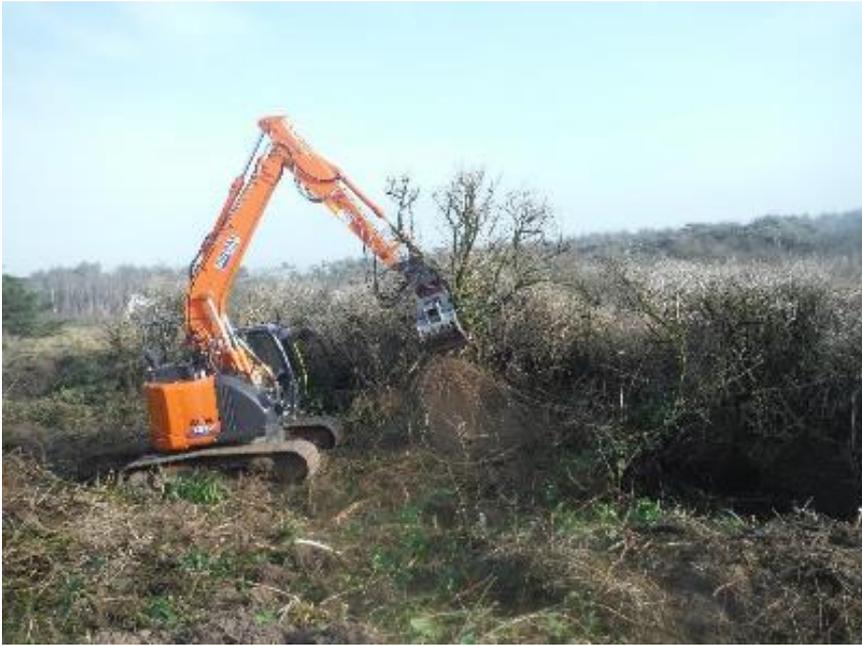
Contractors removing dense sea buckthorn

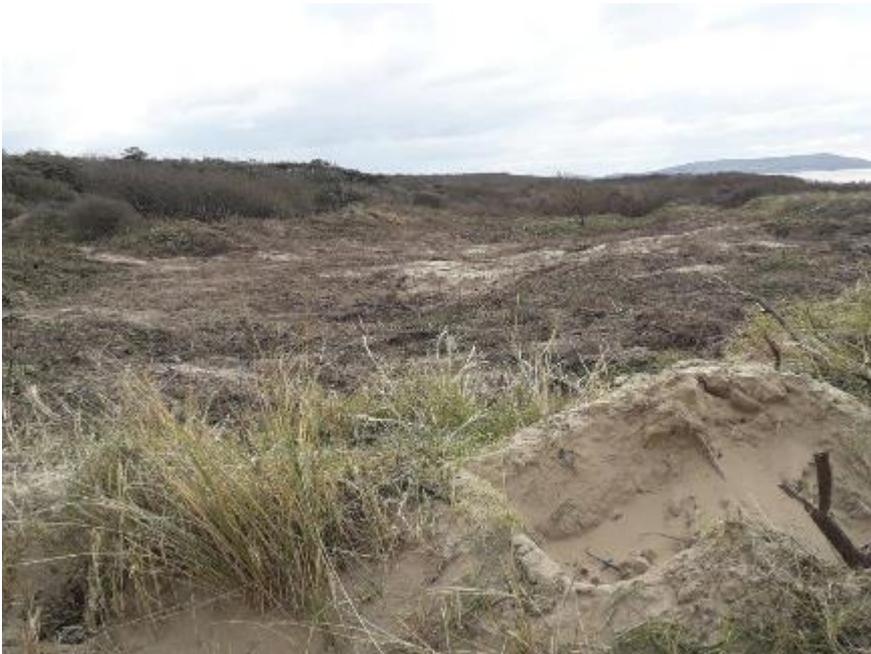
The site after dense sea buckthorn was removed

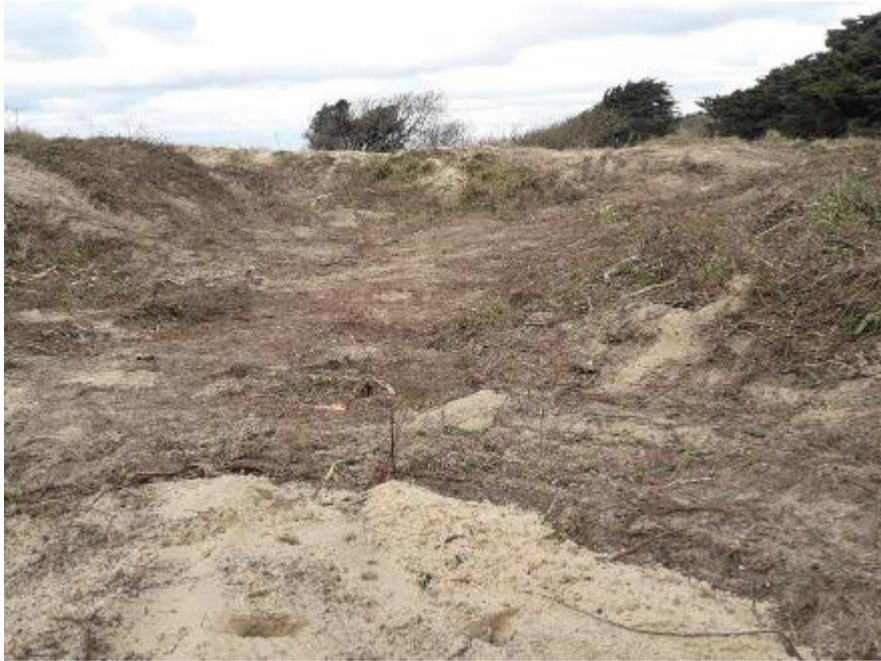
The site after dense sea buckthorn was removed, exposing bare sand

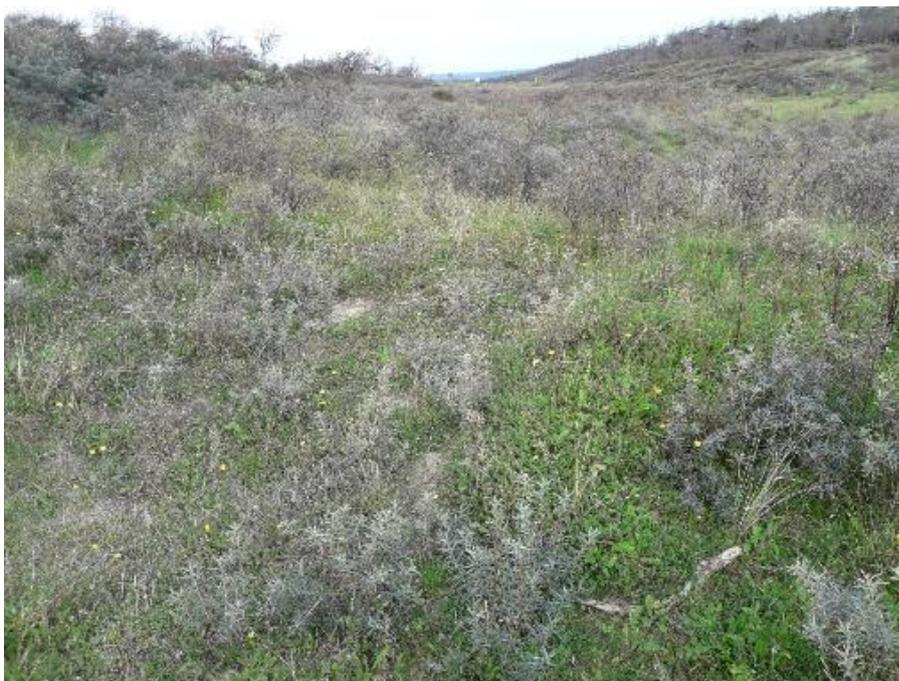
An area of low/medium sea buckthorn growth before works commenced

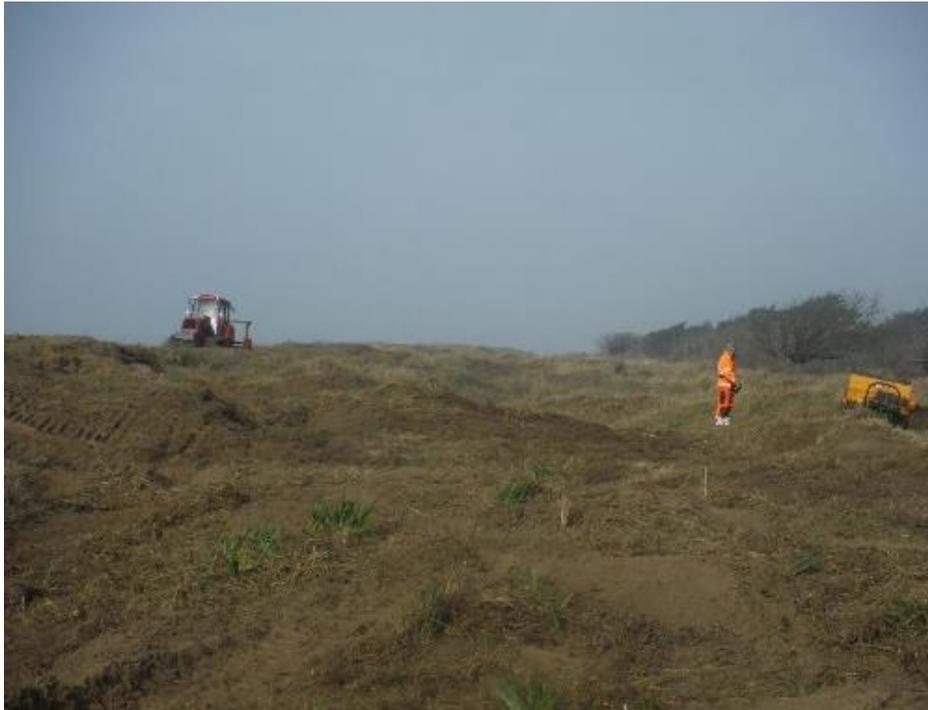
The area of low/medium sea buckthorn growth during mulching

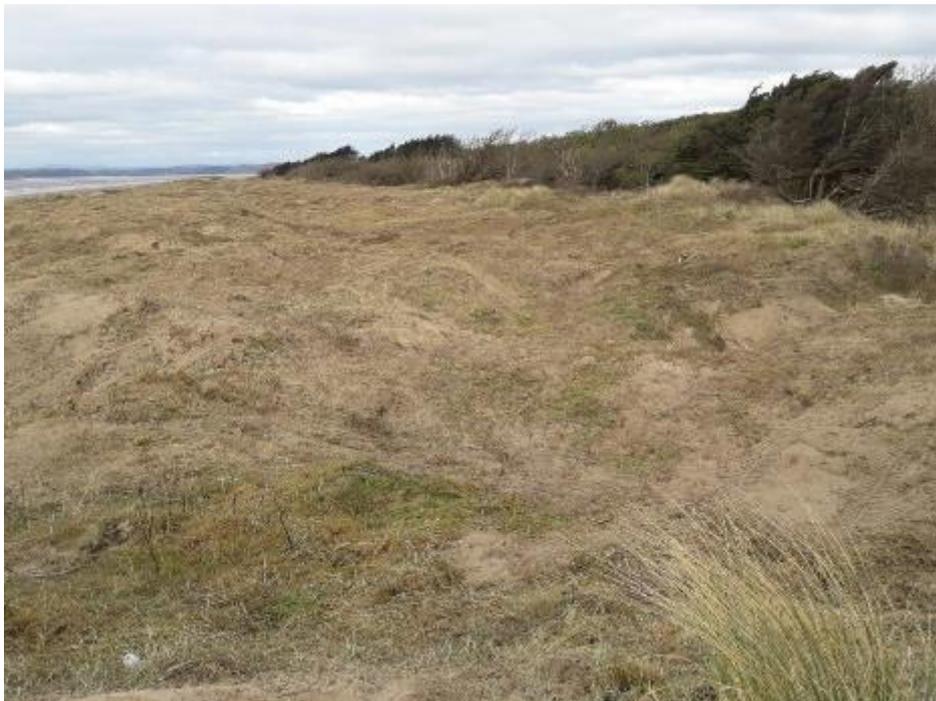
The area of low/medium sea buckthorn growth after works
