Dynamic Dunescapes Dune Management Case Study

Notches and Scrapes, Oxwich, 2021

Sand dune system	Oxwich Burrows (in Oxwich National Nature Reserve, South Wales on South Gower Peninsula)
Case Study Subject	Notch and scrape creation to restore dynamic conditions in the stabilized dune system
The Management Intervention

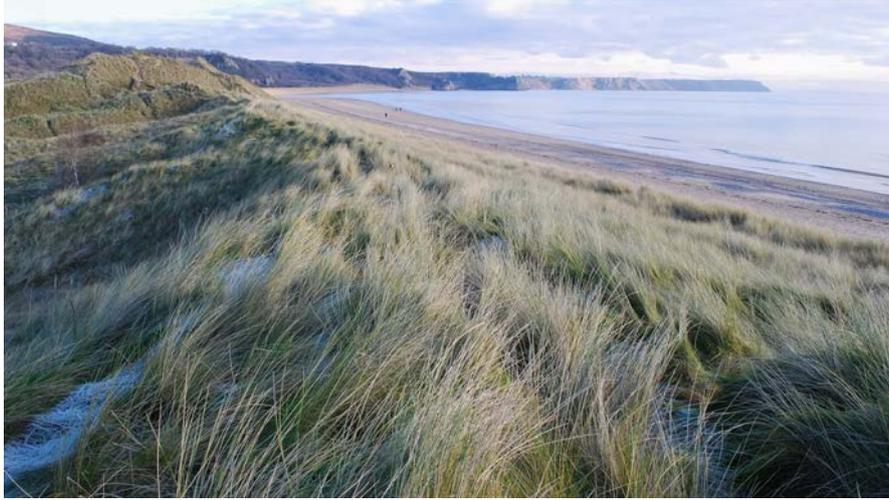
Notch before

The notch in the frontal dune was approximately 20m wide at the top and 10m at the base x 35m long from the beach to the slack.

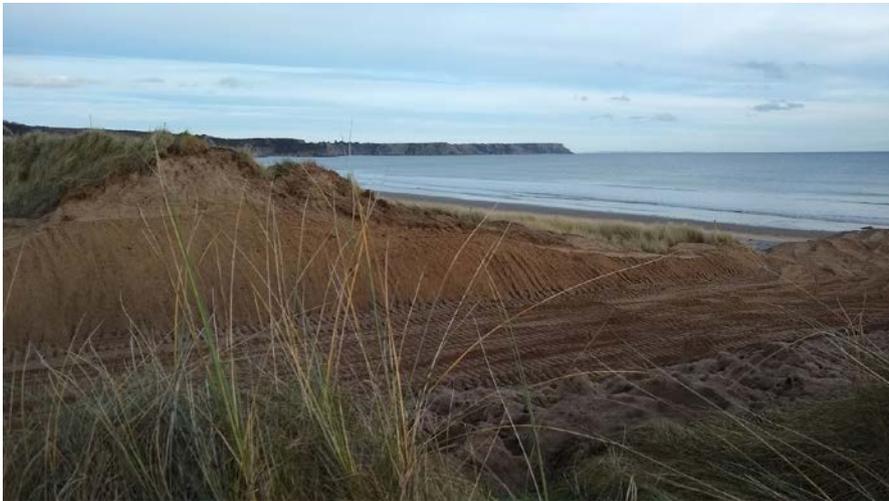
Notch after

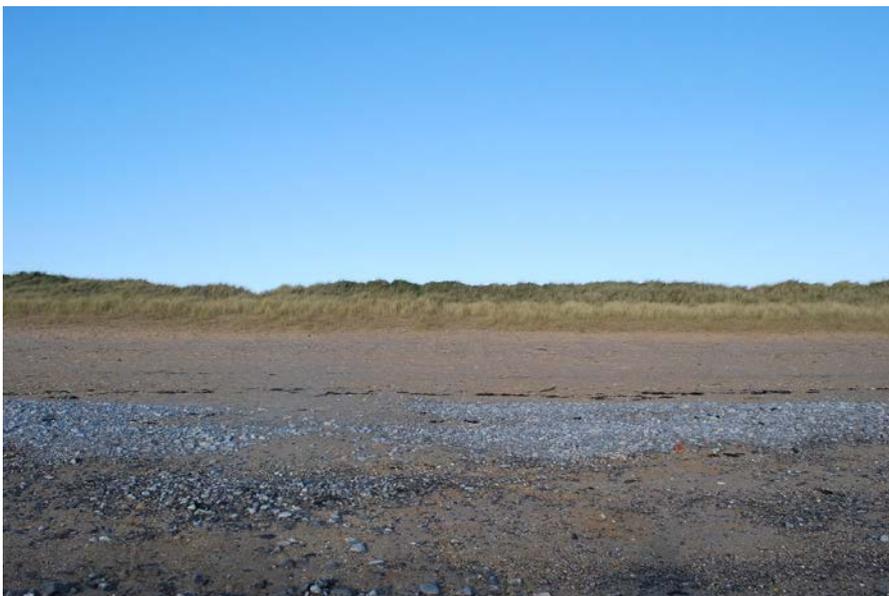
Notch before

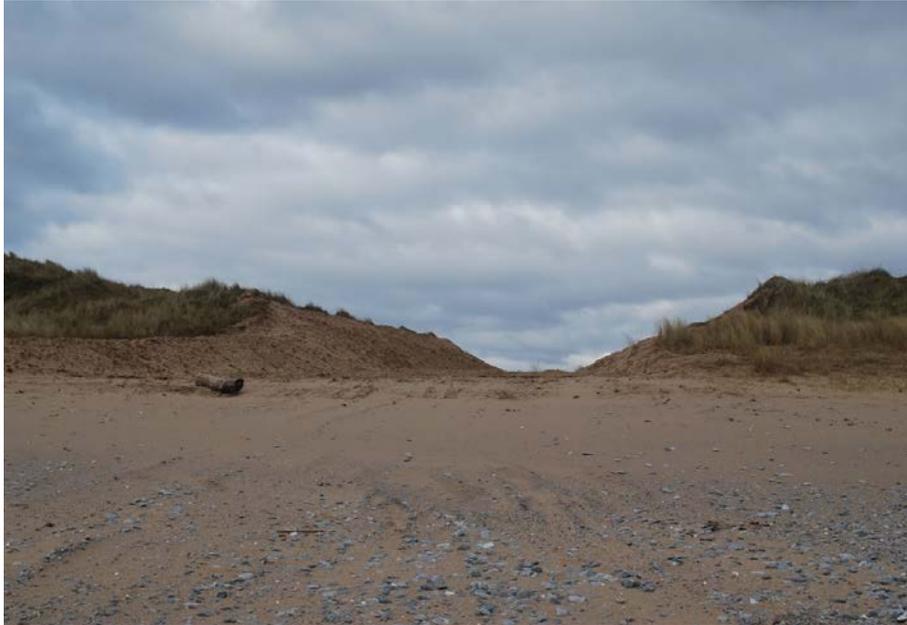
Notch after

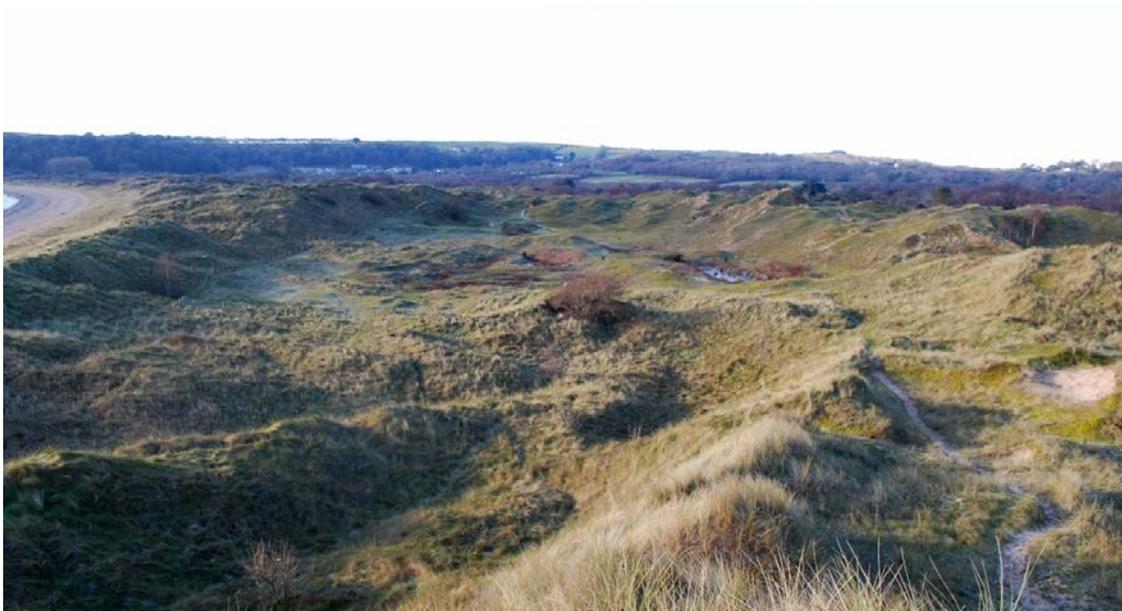
Scrapes before

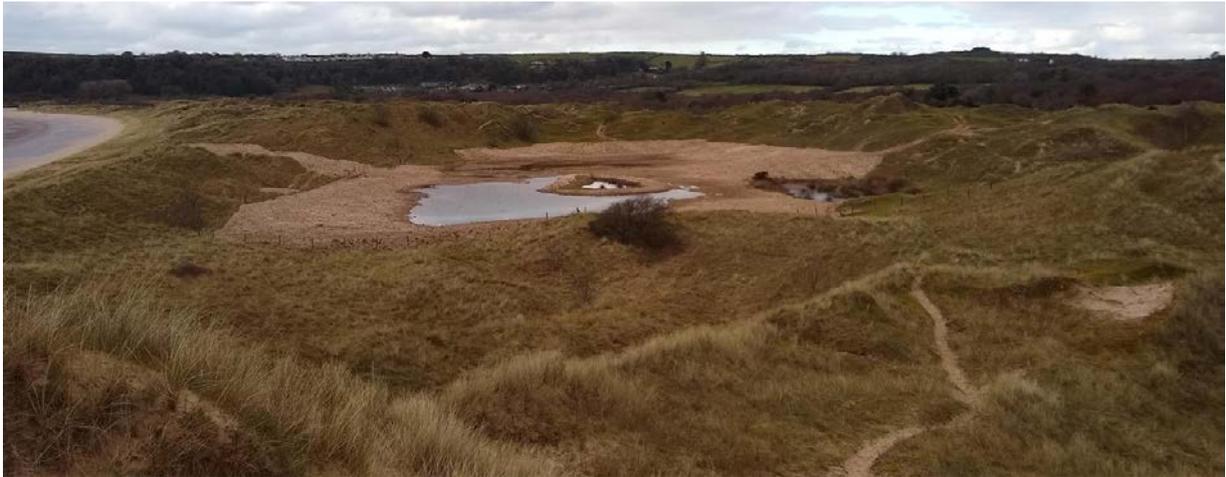
Scrapes after

Before and after photos shows the extent to which new areas scrub removed, notch that has been created, scrape created and the extent of new wet dune slack pools have been created.

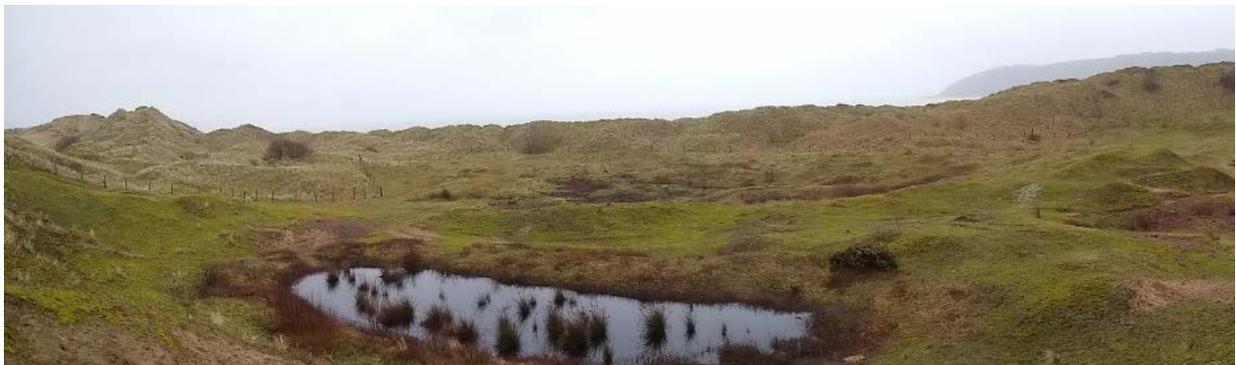
Scrapes before

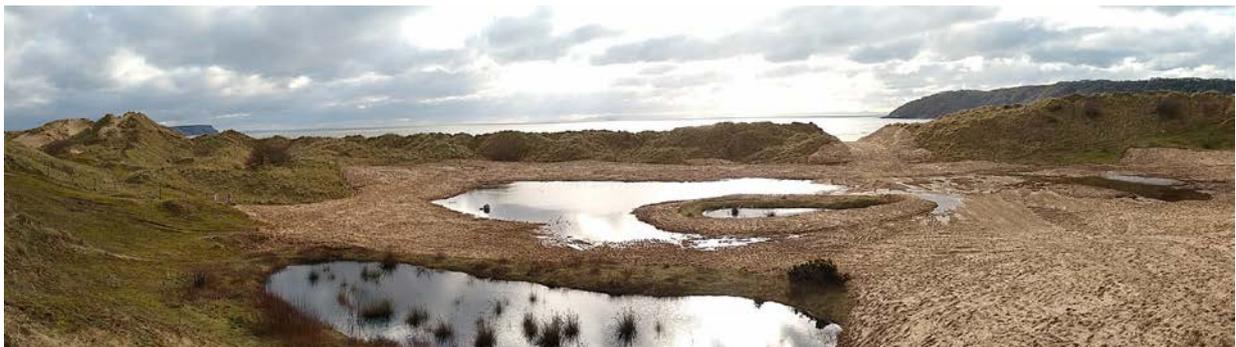
Scrapes after
