# Dynamic Dunescapes Dune Management Case Study Template

| <b>Sand dune system</b> | Sefton Coast |
| <b>Case Study Subject</b> | Notch creation and dune slack rejuvenation 2022-2023 |

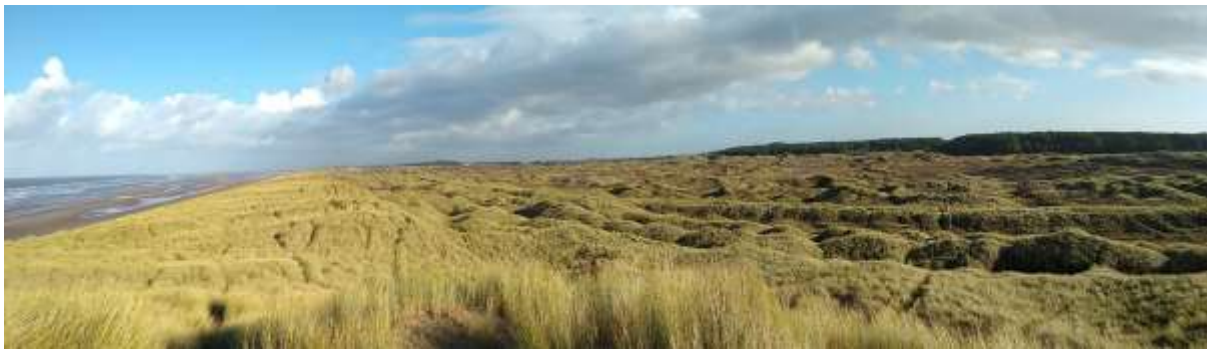
**Photo 1: Frontal dunes at Ainsdale NNR with fixed dune system behind with no bare sand**

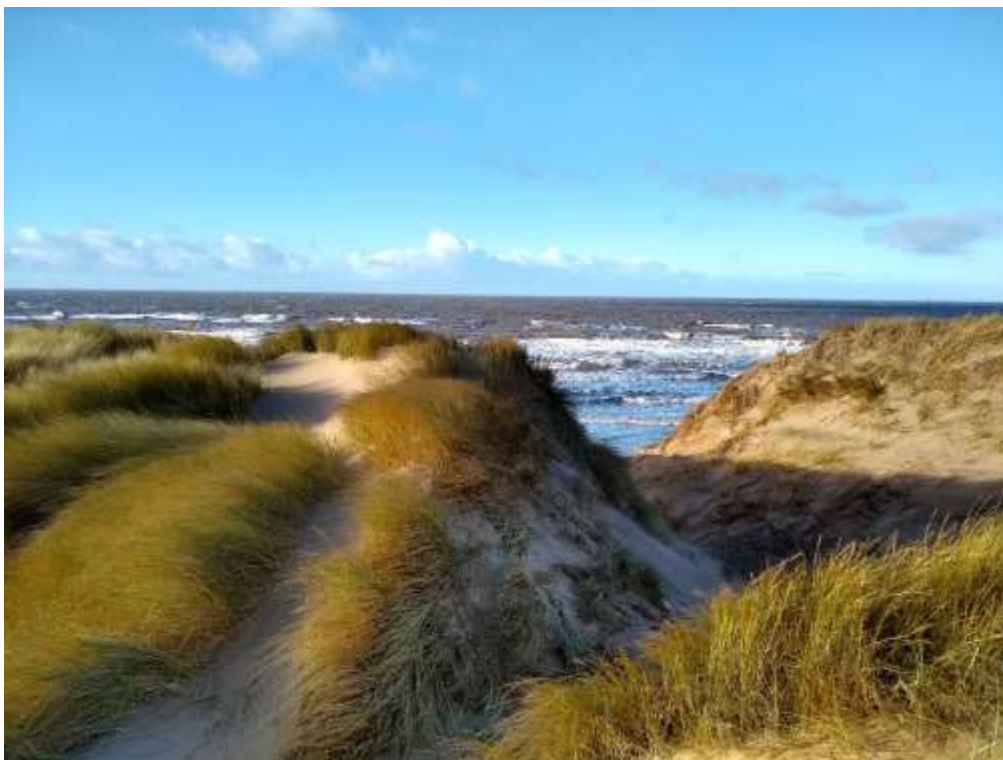
**Photo 2: Existing natural notch**

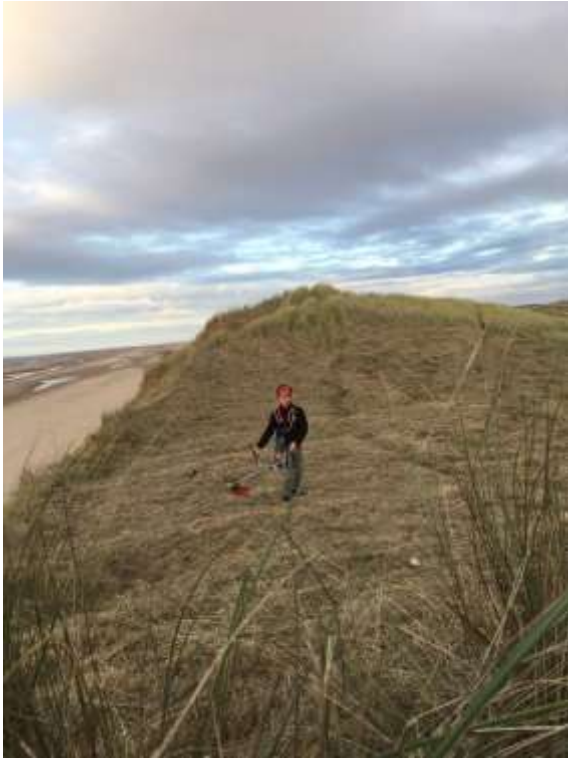
**Photo 3: Mowing the proposed notch area**

To deter sand lizards from moving in prior to the work, our sand lizard experts recommended making the habitat less suitable by mowing the marram grass in the proposed notch areas in winter and removing the resulting thatch. We were also advised to carry out the notching work in a window around the middle of April to the end of May when sand lizards would be active but not yet egg-laying. Ainsdale NNR staff and volunteers started the mowing work over winter in 2019 with the notches proposed for 2020 but due to Covid delays, we ended up repeating the mowing exercise for three winter seasons.

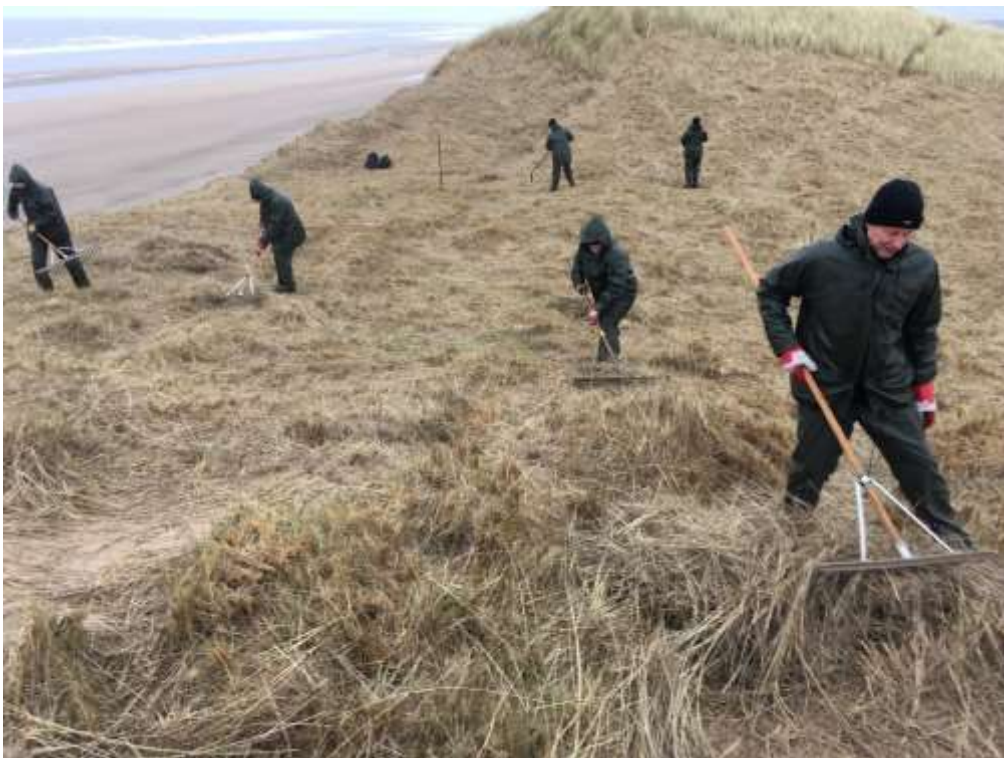
**Photo 4: Volunteers raking mown marram from proposed notch area**

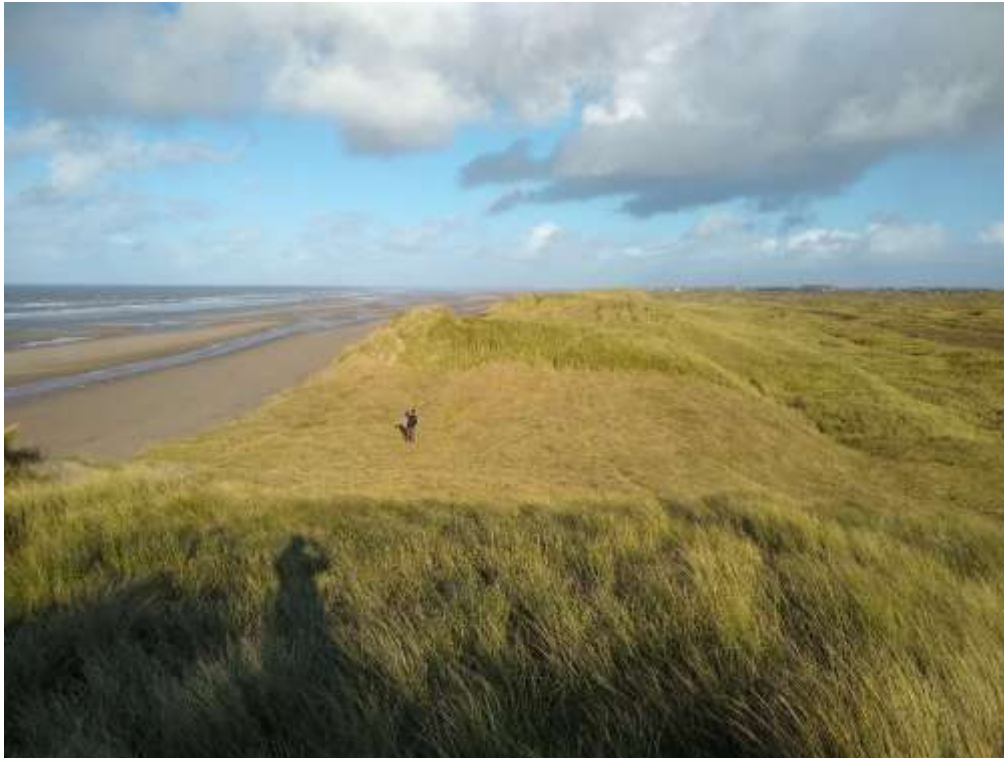
**Photo 5: Mown notch area**

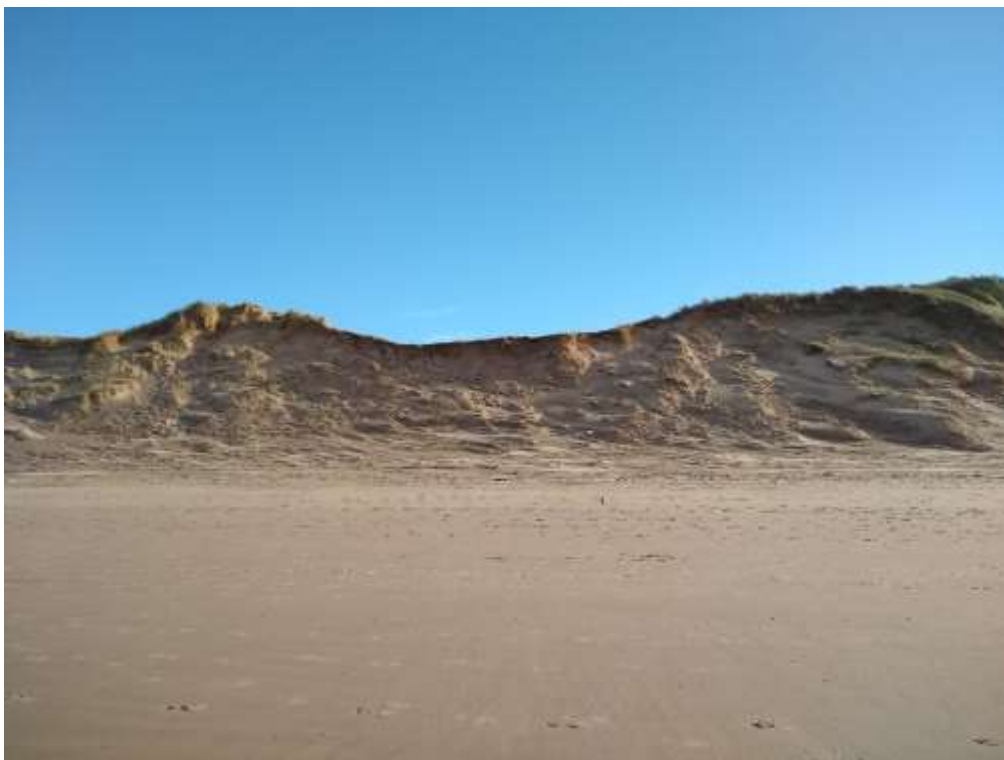
**Photo 6: Proposed notch area from the beach**

The assessment identified several topographical low points in the frontal dunes where it would be possible to create notches. We then compared these to our sand lizard data and took advice from local reptile experts. This resulted in a proposal to create four notches, broadly V-shaped in cross-section, in locations that avoided existing sand lizard populations. The seaward end of the notches would extend almost down to the beach with a base around 3-4m wide. Side slopes would have a maximum angle of 1 in 1 resulting in a width of around 20-25m at the top of the excavation, with the base of the notch rising landward and narrowing slightly. Sand excavated from the notch would be deposited in a lobe immediately behind each notch. The notch should then accelerate the wind in a landward direction, passing sand over the deposition lobe which should be self-sustaining and continue to move into the fixed dune system.

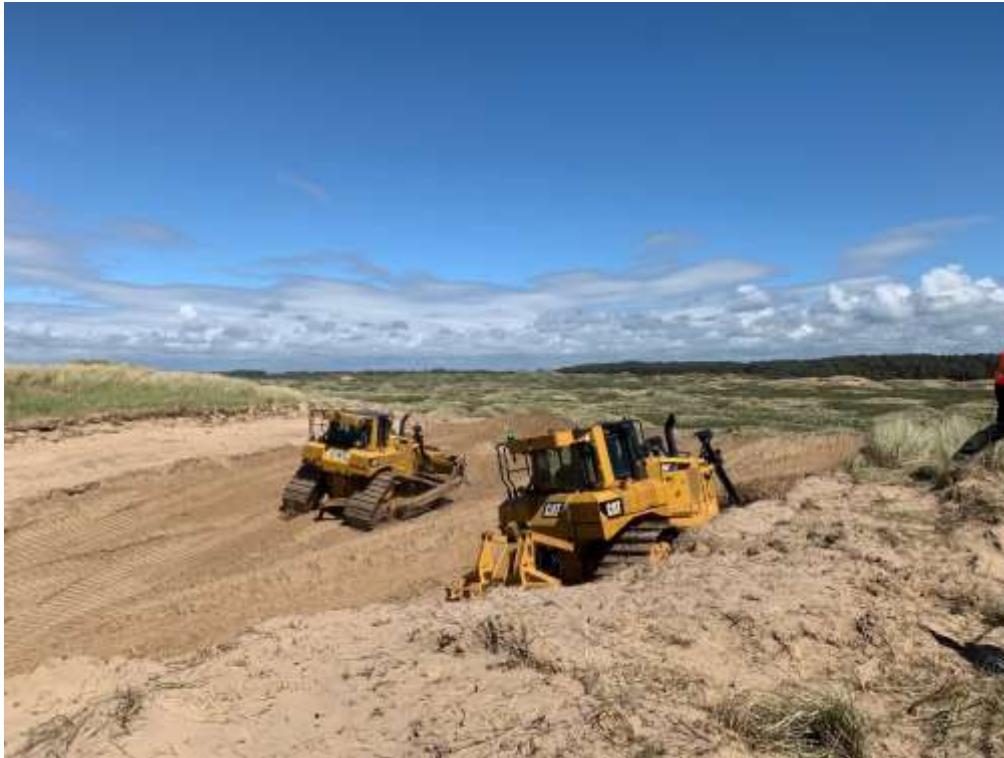
**Photo 7: Notch work underway in May 2022**

To create the notches, contractors used two bulldozers and an excavator which were tracked in via the beach. The work took approximately three weeks to complete.

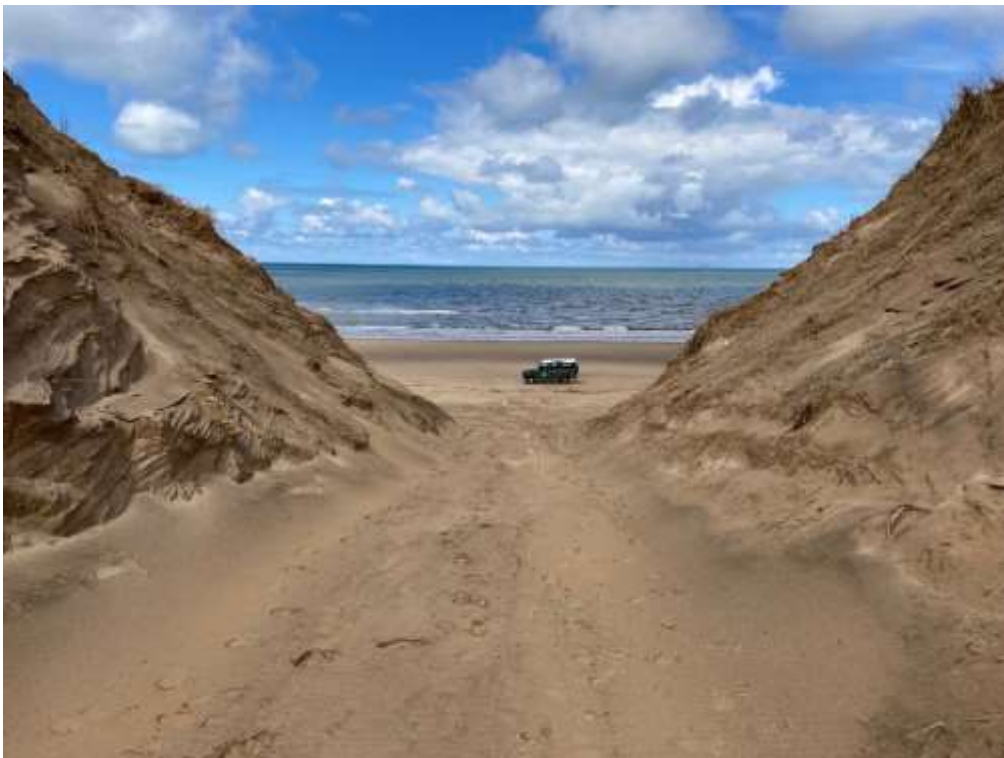
**Photo 8: View through a notch post-completion**

Within days of the notches being completed, we found roe deer tracks going from the beach through one of the notches and into the nature reserve. And in 2023, Ainsdale NNR staff reported finding natterjack tracks through the notches, demonstrating the notches acting as a wildlife corridor between the beach and the inner dunes, improving habitat connectivity which was being restricted by the cliffed frontal dunes.

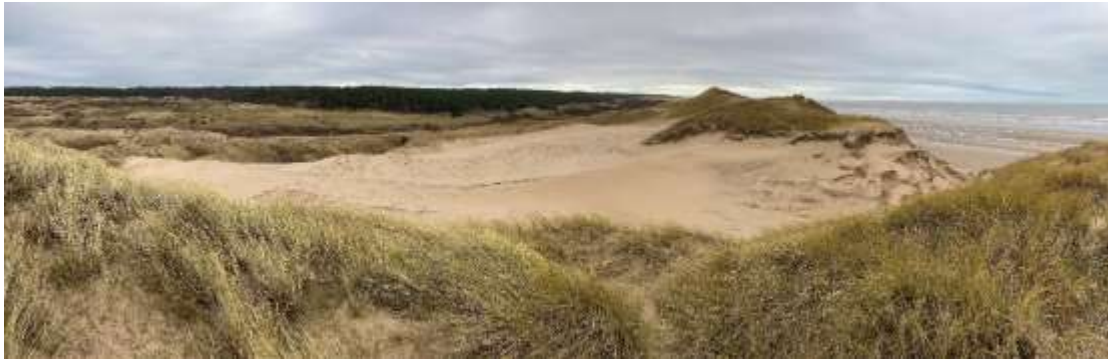
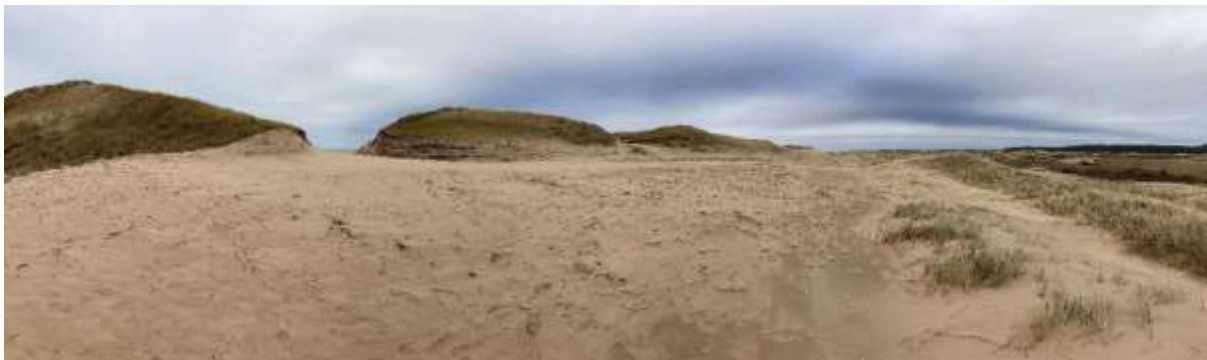
**Photo 9: Notches a year on**

**Photo 10: Notches a year on**

Three of the notch interventions are showing good signs of working so far. Sand has been mobilised by storms and windy weather, pushing the sand lobes further inland, and the dynamic processes from initial observations, are currently self-sustaining. The southern-most notch has moved the least and marram grass is colonising the sand lobe, suggesting some modification is needed to the notch angle and dimensions to increase the flow of wind movement.

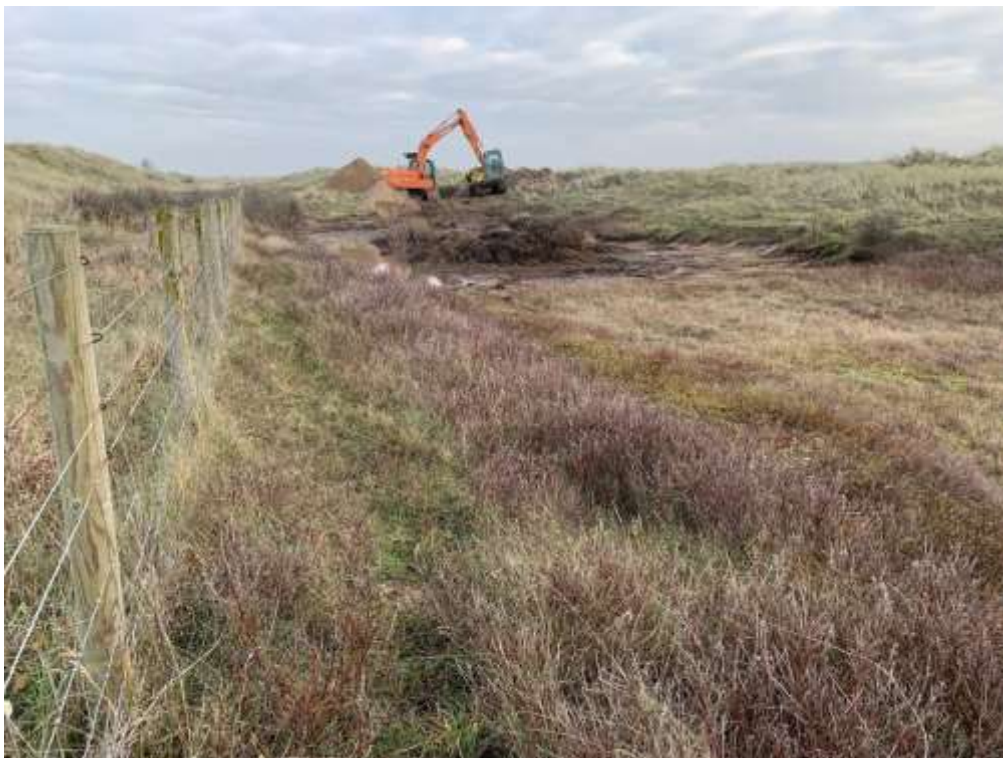
**Photo 11: Slack rejuvenation – removing the overgrown vegetation and humic layer, down to bare sand**

The two dune slacks behind the notch intervention area were mown in autumn 2022 and scraped out in January 2023 to the water table, outside of nesting bird season and when natterjack toads would be hibernating, using an excavator and a tracked dumper operated by Ainsdale NNR staff. The resulting plant material was buried on site and capped with sand from the excavation.

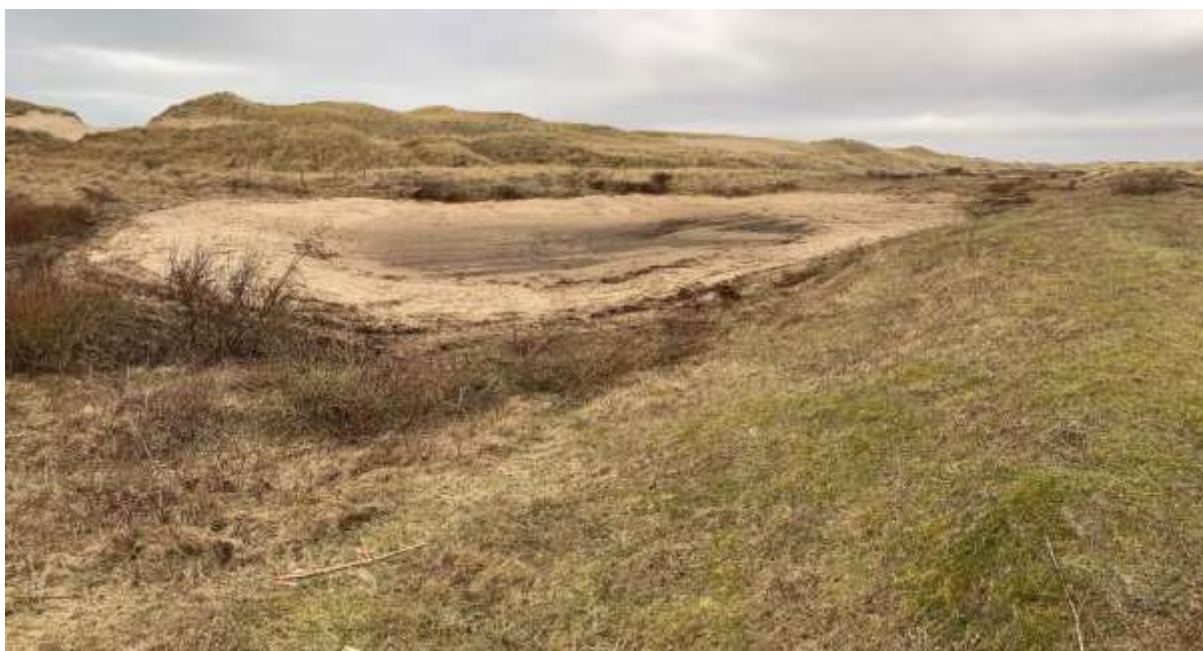
**Photo 12: Completed dune slack scrape in February 2023**

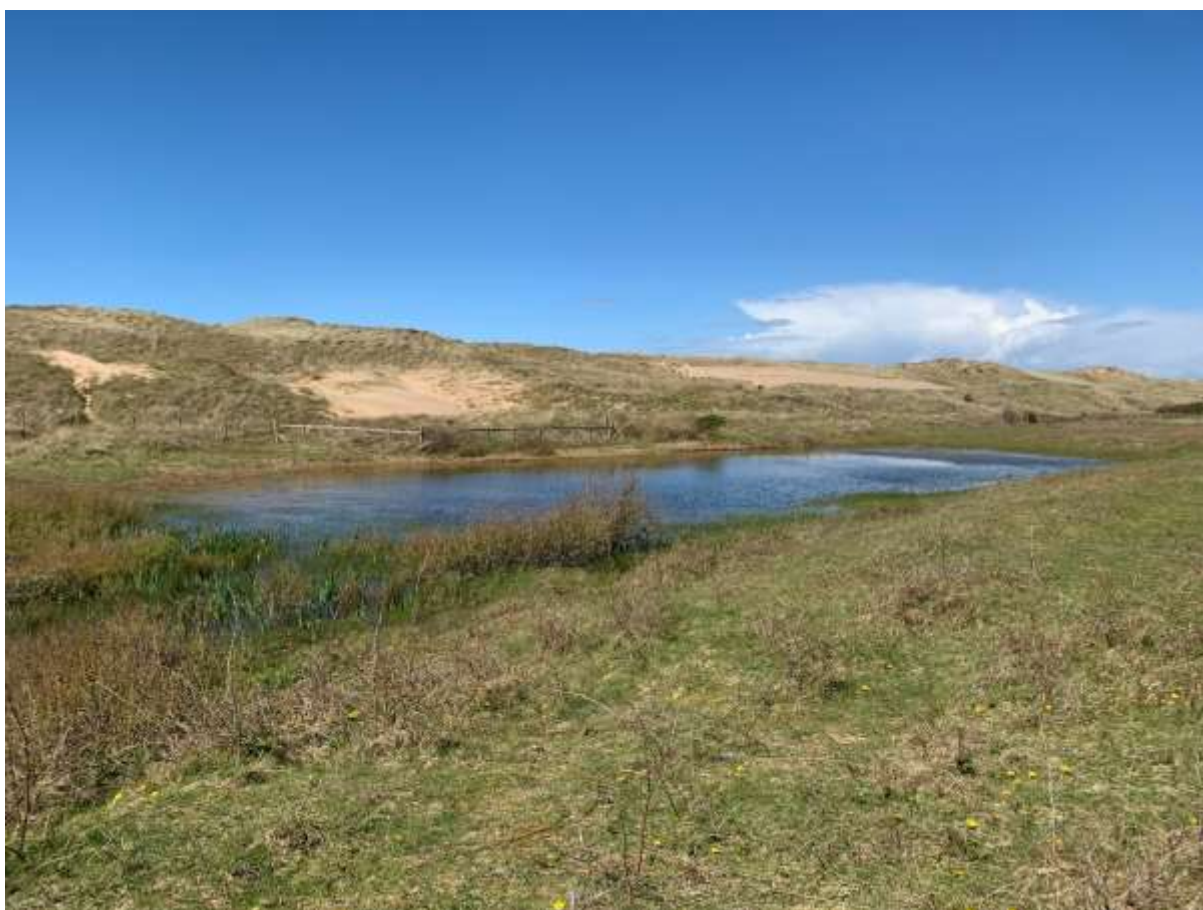
**Photo 13: Dune slack scrape in April 2024 with the sand from the notches in the background**
